**National Highway
Traffic Safety
Administration**

Case Vehicle (A): 2000 Ford
Type: Expedition Eddie Bauer 4 x 4, 4-door SUV
Driver: 50-year-old female
CDC: 12-FRLE-3

Vehicle (B): 1989 Ford
Type: Taurus LX, 4-door sedan
Driver: 33-year-old female
CDC: 99-0000-0

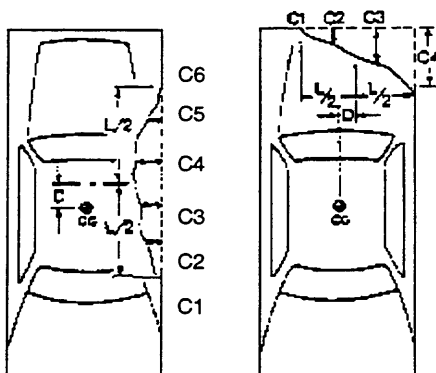
Specific Impact Number	Plane of Impact C-Measur.	Direct Damage		Field L	C_1	C_2	C_3	C_4	C_5	C_6	$\pm D$
		Length (DDL)	Max Crush								
1	1	46	28	164	18	5	1	1	8	28	+59
			-18		-18	-5	-1	-1	-5	-18	
1	1	046	010	164	000	000	000	000	003	010	+059
13	14	15 16 17	18 19 20	21 22 23	24 25 26	27 28 29	30 31 32	33 34 35	36 37 38	39 40 41	42 43 44 45
2

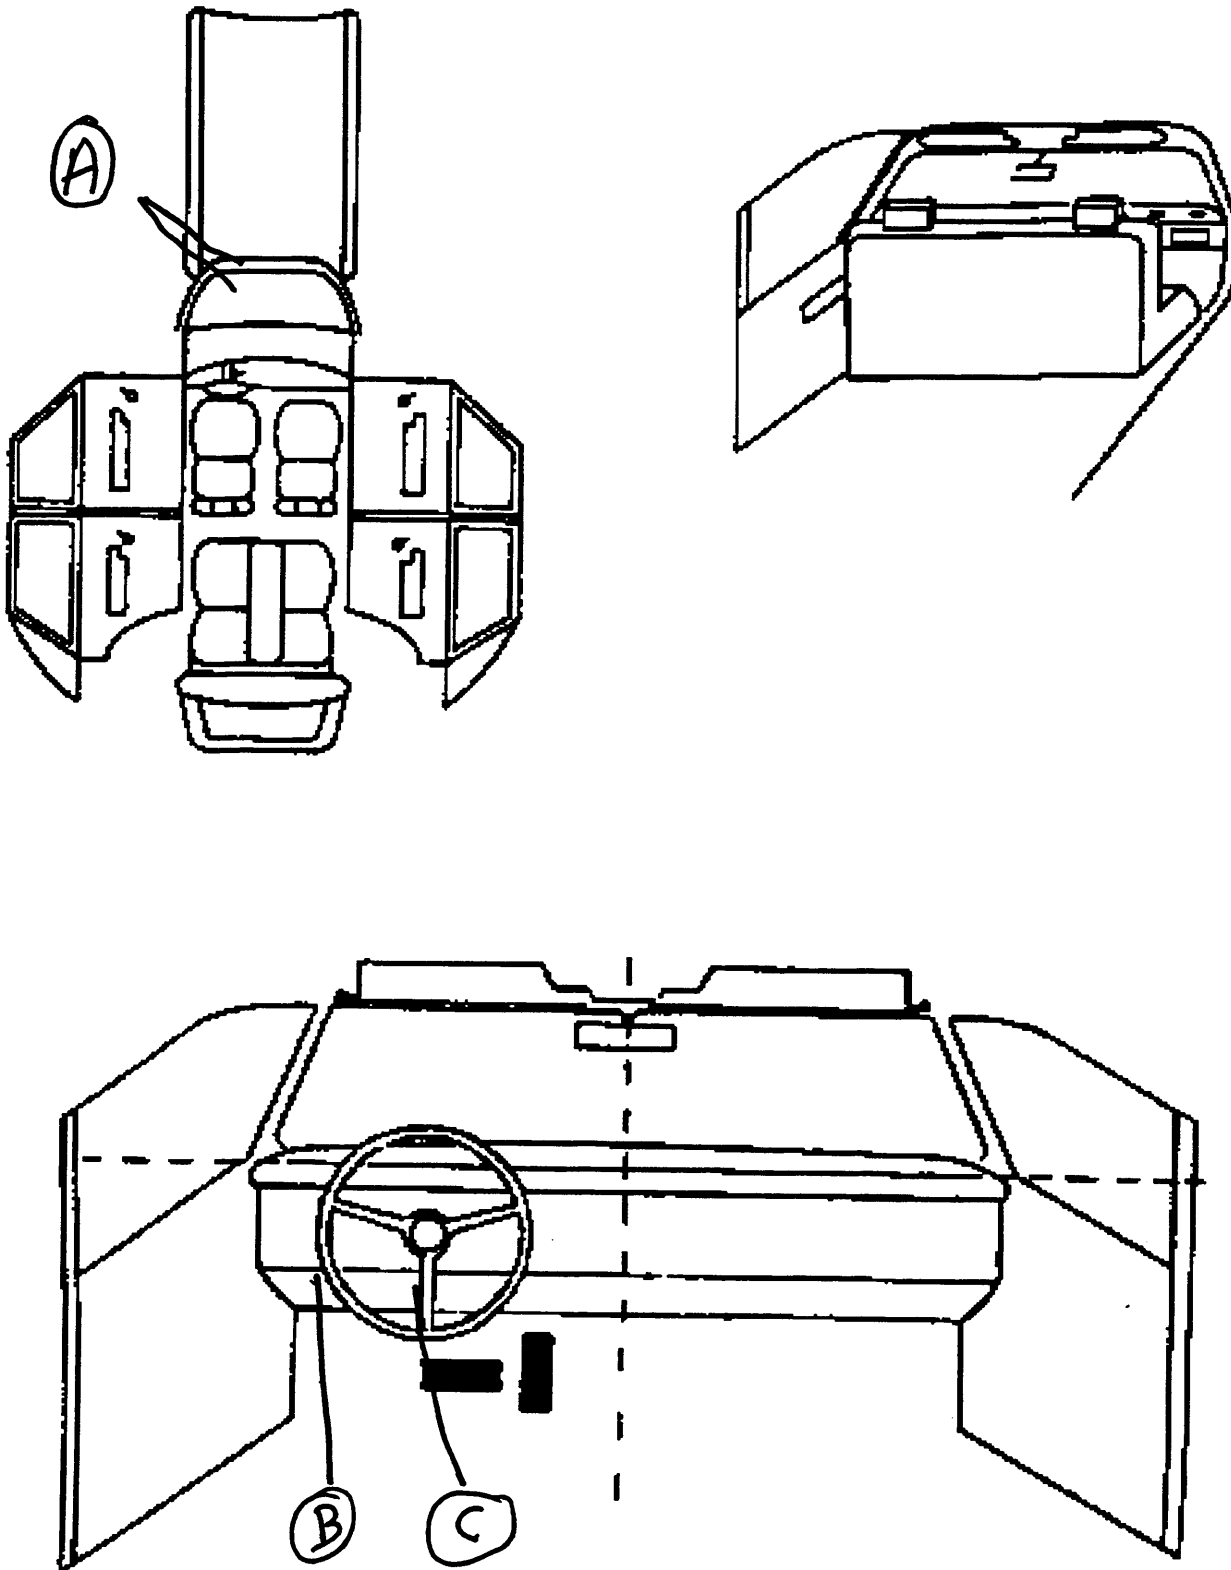
VEHICLE OCCUPANT CONTACT DIAGRAM

Contact	Interior Component Contacted	Occupant No. if Known	Body Region if Known	Supporting Physical Evidence	Confidence Level of Contact Point
A	WINDSHIELD/HEAD	DA	Lt. Hand	windshield cracked (DIAMOND ring)	1
B	KNEE bolster	DA	Lt knee	Dent	1
C	KNEE bolster	DA	Rt knee	Stress mark	1
D					
E					
F					
G					
H					
I					
J
